**Project:** City of Ashland Transportation System Plan Update

**Subject:** Technical Memorandum #4 Existing System Conditions

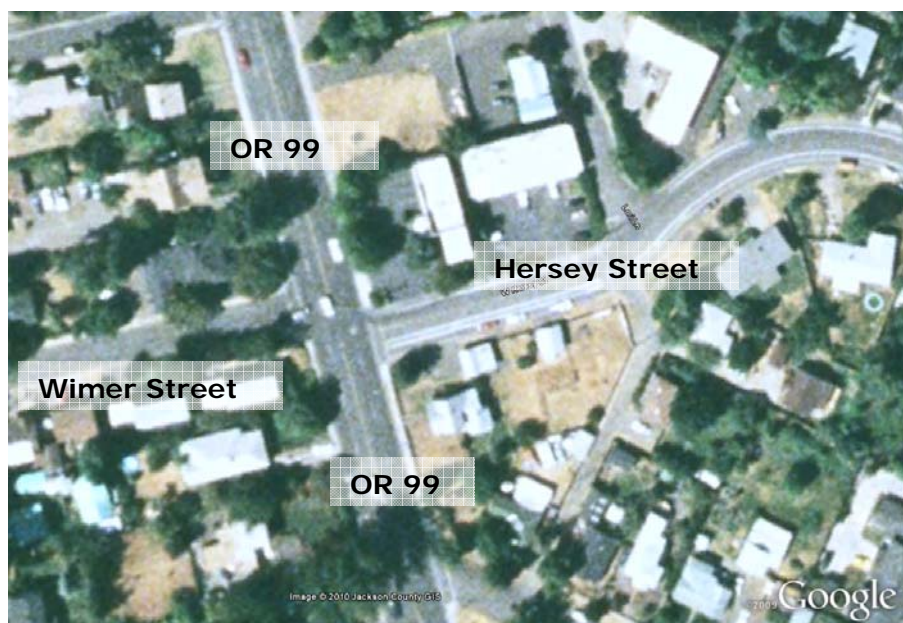
#### **Exhibit 2 OR 99/ Hersey Street/Wimer Street**

Exhibit 2 is an aerial view of the intersection from Google Earth illustrating the physical characteristics noted above.

- The majority of the reported crashes were rear-end crashes or turning crashes;
- The majority of the turning crashes (i.e., 18 out of 21 reported turning crashes) occurred when motorists waiting to turn left off of OR 99 onto the minor street turned in front of on-coming traffic;
- Slightly more than half of the reported rear-end crashes (i.e., 7 out of 13 reported rear end crashes) occurred when motorists waiting to turn left off of OR 99 were hit from behind by a motorist traveling straight on OR 99;
- Four crashes at the intersection were related to bicyclists or pedestrians attempting to cross OR 99; and
- Three crashes at the intersection were related to motorists misjudging gaps in traffic or failing to see approaching traffic while attempting to cross OR 99 from Hersey Street to Wimer Street or the reverse.

- **Convert access to Hersey Street and Wimer Street to right-in/right-out access only** – Restricting access to these minor streets to right-in/right-out only would eliminate collisions related to motorists turning left onto or off of OR 99 as well as crashes related to motorists crossing OR 99 from Hersey Street to Wimer Street or the reverse. Left-turn access to and from OR 99 could be served to the north through the signalized Maple Street/OR 99 intersection or to the south through the signalized OR 99/Helman Street intersection. This countermeasure is noted because 28 of the 42 reported crashes at the intersection were related to left-turning or crossing maneuvers.

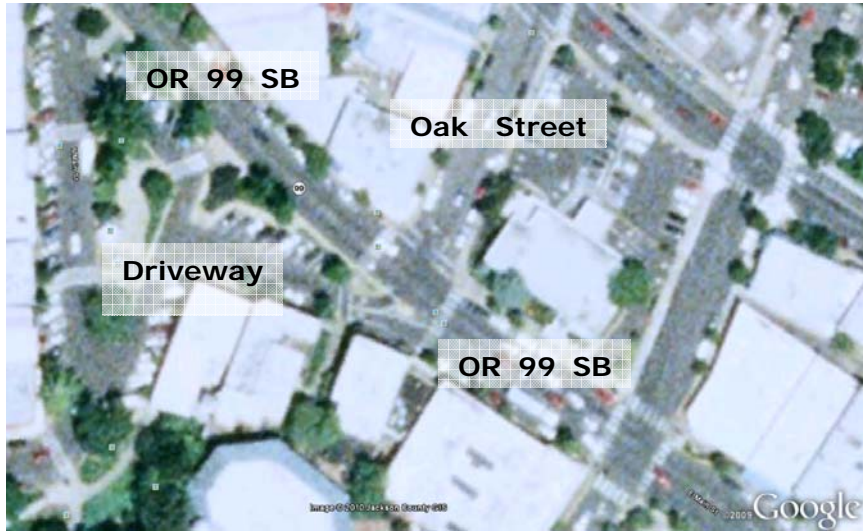
### Exhibit 3 OR 99 SB/Oak Street

Exhibit 3 is an aerial view of the intersection from Google Earth illustrating the physical characteristics noted above particularly the driveway opposite of Oak Street which intersects OR 99 SB at a skewed angle.

- Over half of the crashes reported at the intersection were turning related crashes and of those the majority involved improper turns in which motorists were distracted and/or failed to yield the right-of-way appropriately; and
- The majority of crashes at the intersection were property damage only crashes, which generally indicates the crashes that do occur are occurring at slower speeds as motorists navigate a busy urban area.

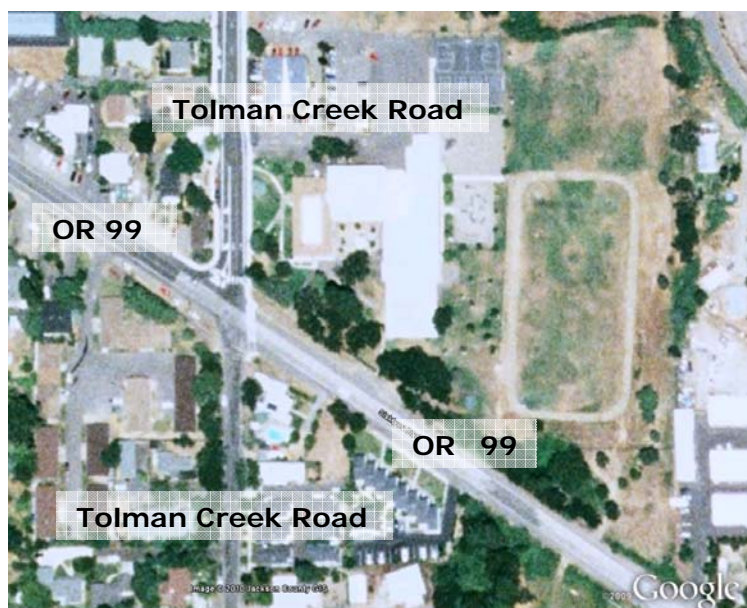
#### Exhibit 4 OR 99/Tolman Creek Road

Exhibit 4 is an aerial view of the intersection from Google Earth illustrating the physical characteristics noted above.

- The majority of the reported crashes were angle crashes; and
- The majority of the angle crashes occurred when vehicles were attempting to cross OR 99 or turn onto OR 99; motorists appear to misjudge approaching vehicle speeds or fail to see approaching vehicles.

Based on the physical conditions at the intersection and the reported crashes, drivers appear to have difficulty judging approaching speeds or seeing approaching vehicles. Potential countermeasures include:

- **Prohibit parking on OR 99 in the vicinity of the intersection** – Based on photos on Google Earth, parking on the shoulder of OR 99 appears to be permitted, which may inhibit motorists' sight distance at the intersection.
- **Conduct a speed study and investigate potential speed reduction treatments** - A pertinent next step could be to conduct a speed study to determine prevailing vehicle speeds on OR 99 and if they are higher than appropriate for the desired conditions. This could be the case given the change in the posted speed limit from 45 mph to 35 mph on approach to the intersection. This is also the area in which OR 99 begins to change in function from a non-urban highway-type function to a facility passing through an increasingly urban area that provides access as well as mobility to travelers. If prevailing

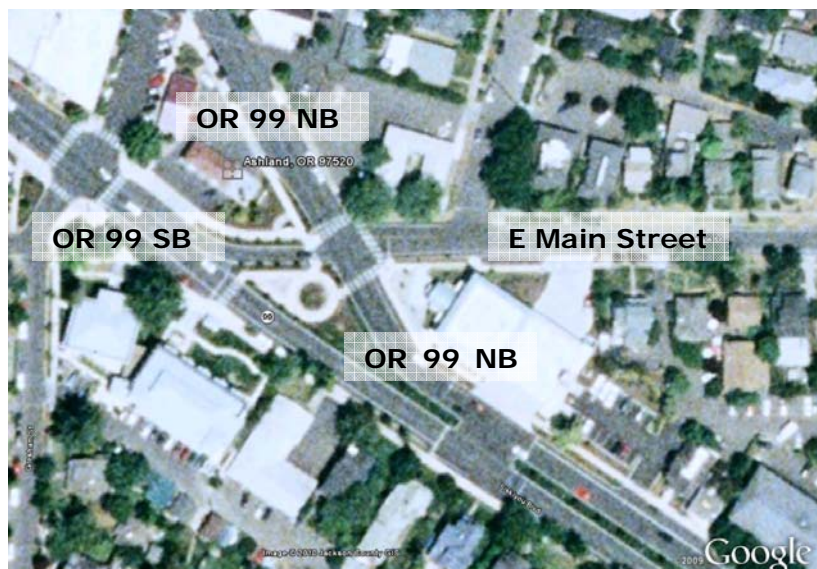
### **Exhibit 5 OR 99 NB/E Main Street**

Exhibit 5 is an aerial view of the intersection from Google Earth illustrating the physical characteristics noted above.

- The majority of reported crashes are rear end crashes that occurred when motorists were following too close or were distracted;
- The angle/turning crashes at the intersection occurred when motorists disregarded the traffic signal and/or failed to yield to pedestrians in the crosswalk.

In general, the types of crashes noted above are consistent with what is expected to occur at signalized intersections. A potential countermeasure that may help reduce crashes particularly those related to disregarding the traffic signal could be automated enforcement such as red-light running cameras. It is important to note while red-light running cameras tend to help reduce crashes related to disregarding the traffic signal, in some instances they have been found to increase the occurrence of rear-end crashes.

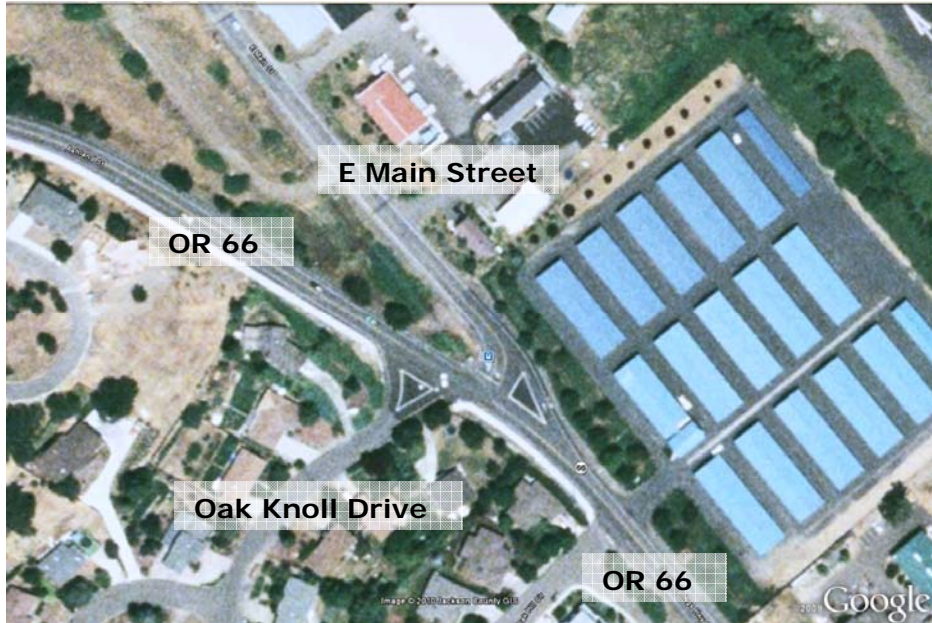
## Exhibit 7 OR 66/E Main Street/Oak Knoll Drive Intersection

Exhibit 7 is an aerial view of the intersection from Google Earth; the horizontal curve, intersection skew, and offset minor street approaches noted above can be seen.

- The majority of the crashes are rear end crashes or angle/turning crashes;
- The rear end crashes tend to occur when a vehicle is stopped on OR 66 waiting to turn left onto E Main Street or Oak Knoll Drive; and
- The angle/turning crashes tend to occur when a vehicle is attempting to cross OR 66 (traveling from E Main Street to Oak Knoll Drive or the reverse). They also tend to occur when a vehicle turning off of or onto OR 66 fails to yield or give the right-of-way to through traffic on OR 66.

Based on the physical conditions in the field as well as the crash types and events documented in ODOT's crash data, it appears motorists may have minimum or inadequate sight distance at the intersection. A lack of sight distance could be contributing to the rear end crashes on OR 66 because motorists traveling along OR 66 do not have adequate time and distance to identify and react to vehicles stopped in the roadway waiting to turn. Similarly, motorists attempting to turn to, from, or crossing OR 66 may not have adequate sight distance to identify and react to acceptable gaps in traffic for turning and crossing maneuvers and/or may misjudge gaps.
